AGS (HK) Technical Seminar

Engineering Geological and Geotechnical Challenges

of Lin Ma Hang Lead Mine Revitalization –

A Unique Community-based Educational Mining Heritage Project

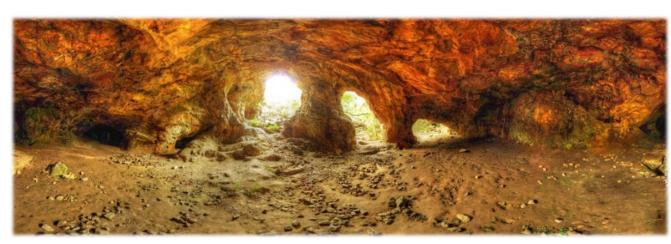
Panoramic View of Lin Ma Hang Main Cavern (before works)

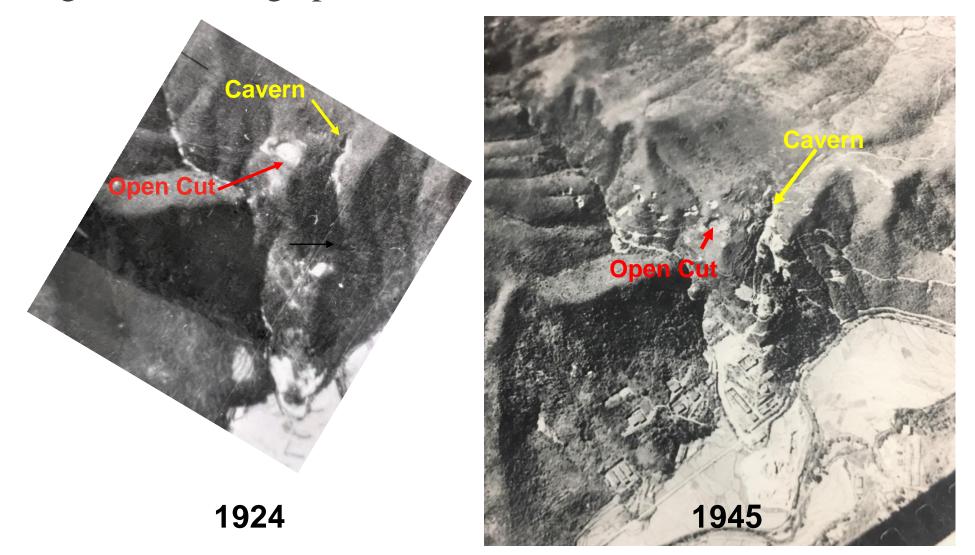
Exciting Aerial Photographs in 3D – 1924 & 1945

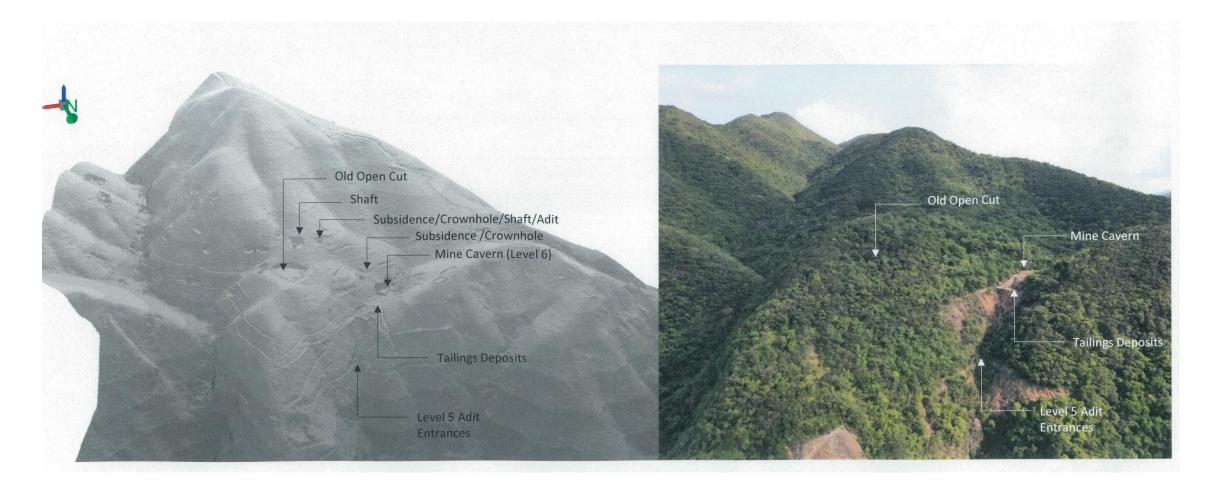
Comparison 2021 Colour 3D & 3D LiDAR

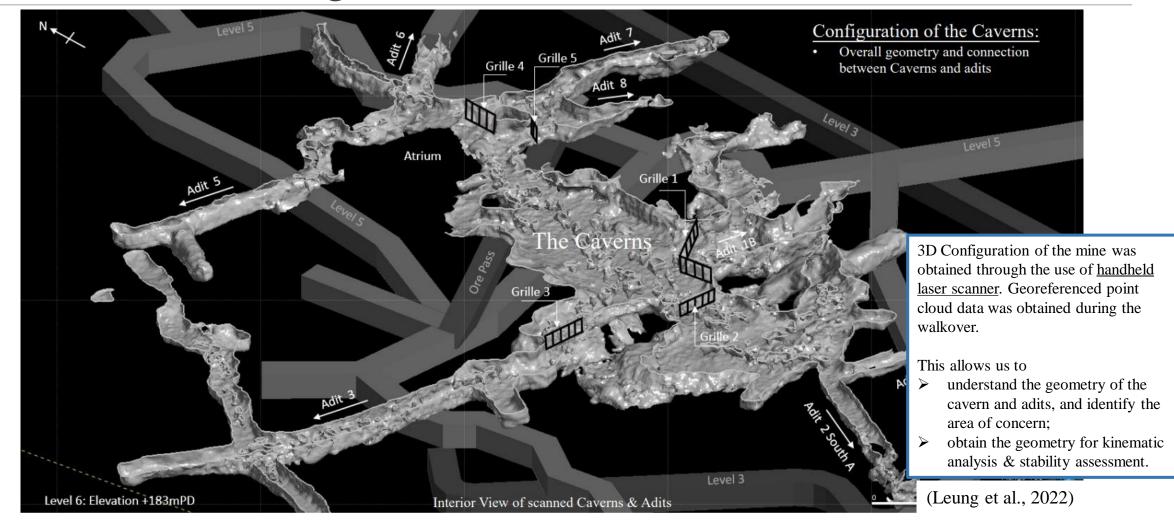
3D LiDAR Configuration of Cavern, Atrium & Adits

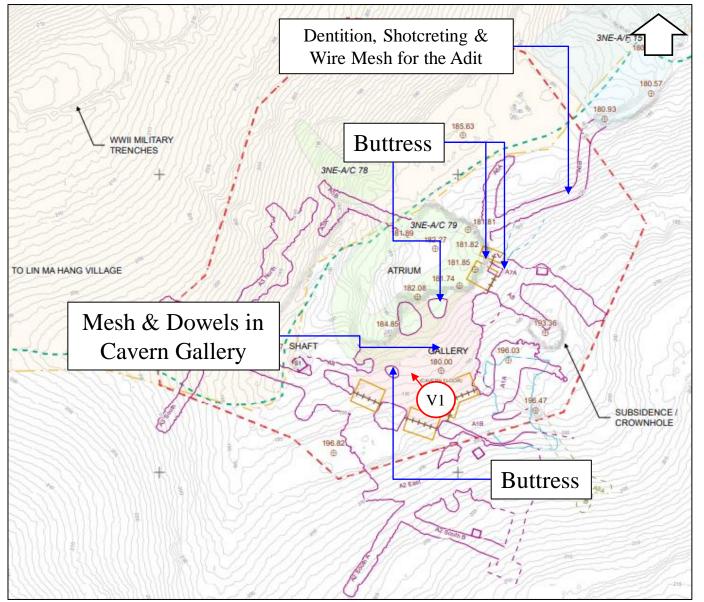
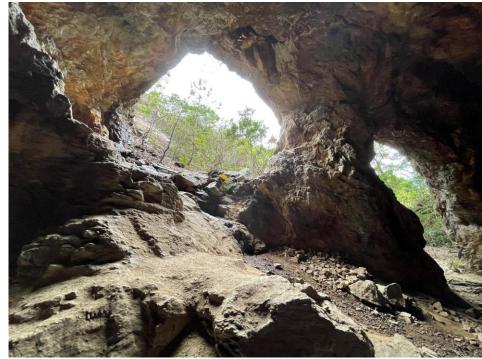
As-built Precautionary & Mitigation Measures for the Cavern & Adit

Cavern Gallery (View V1)

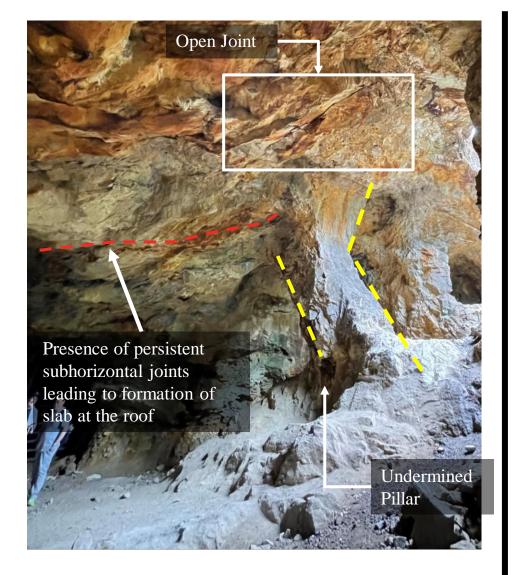
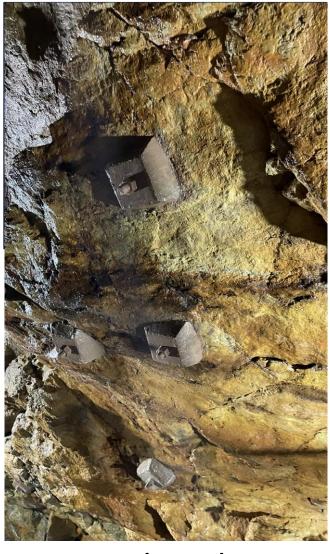
Buttress

Major Adopted Mitigation Measures against the Identified Risks

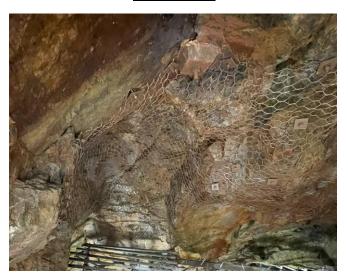
Rock Dowels

Wire Mesh

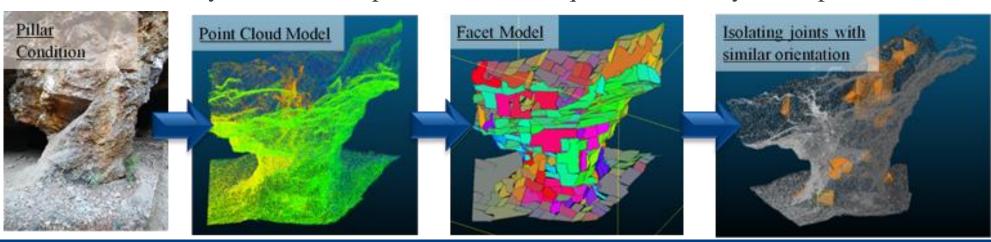
- Adopted NGI Q System (NGI, 2022) for rock mass assessment & pattern rock dowels
- Additional spot dowel & verification of pattern dowel locations during construction to cater for local instability
- Innovative use of hand-held laser scanner technology to capture geometry for stability assessment, i.e. kinematic analysis for roof & pillar + Limited Equilibrium Analysis for pillars

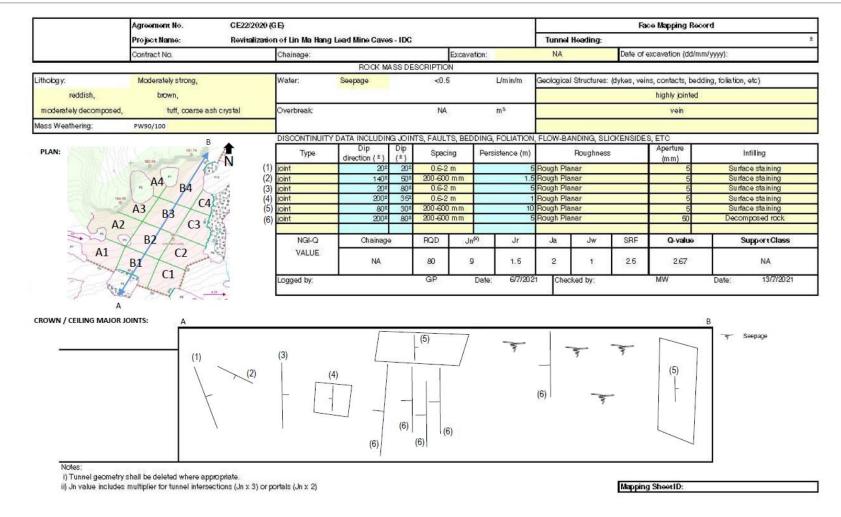
Locally persistent discontinuities near southern portion of main cavern in which no rock-wall contact recorded & infill >50mm in thickness

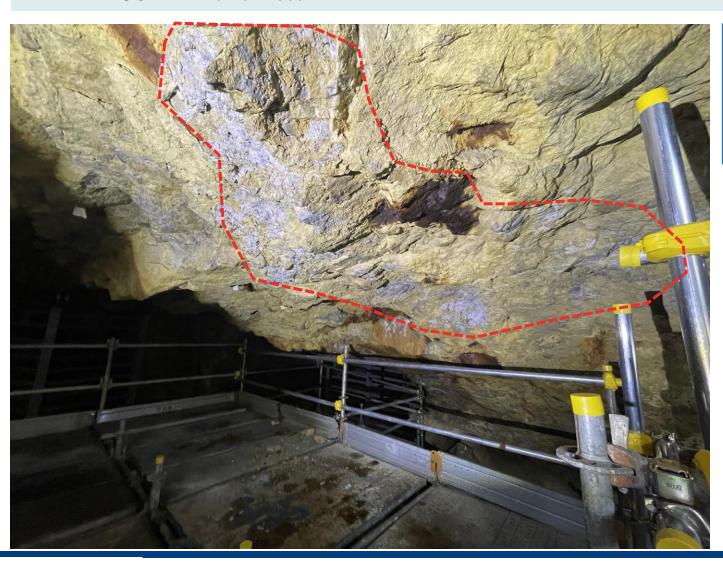
Appeared intact & strong at distance, but easily crumbled by hand

- Solution: required protection with wire mesh shotcreting not preferred option for landscaping reason

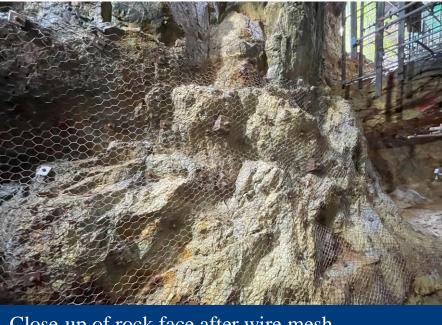
Close-up of rock face after wire mesh

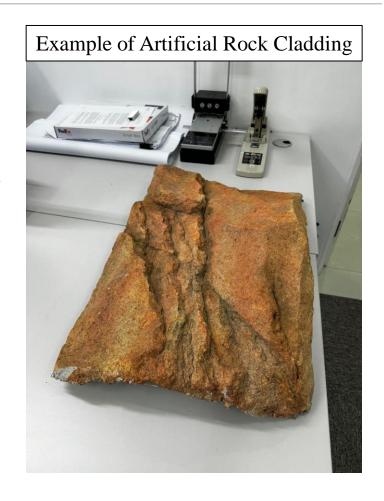
- Provision of **suitable rock coloured pigments** to rock dowel head & wire mesh to blend in with the rock colour
- Provision of artificial rock cladding for concrete surfacing works

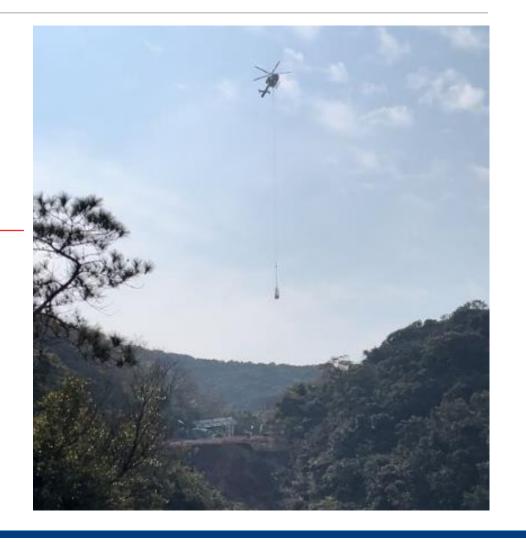
"998 STEPS" without vehicular access to reach site at
 +181mPD

- Deployed airlift operations by helicopters for material/machinery delivery & removal of construction waste

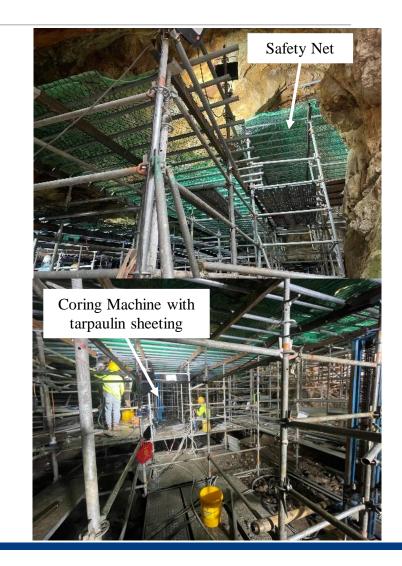
- Utilize electrical coring machine with water flushing, enclosed by tarpaulin sheeting for noise & dust reduction
- \rightarrow Minimize disturbance to bat populations

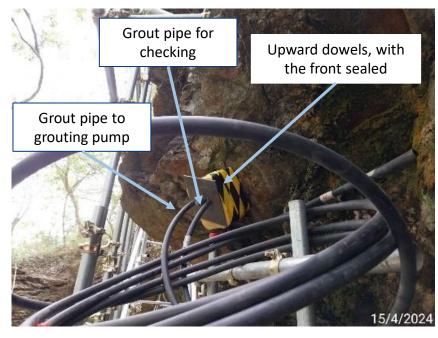
- Presence of interconnected joint networks & blast-induced open apertures create difficulties in grouting
- ∘ → Multi-stage grouting procedure
 - i. Using more diluted grout at beginning to seal joints & cracks
 - ii. Using typical cement-water ratio grout for grouting dowels
- → Additional benefit: Reduction of water ingress into the Caverns Gallery

Grouting works in progress

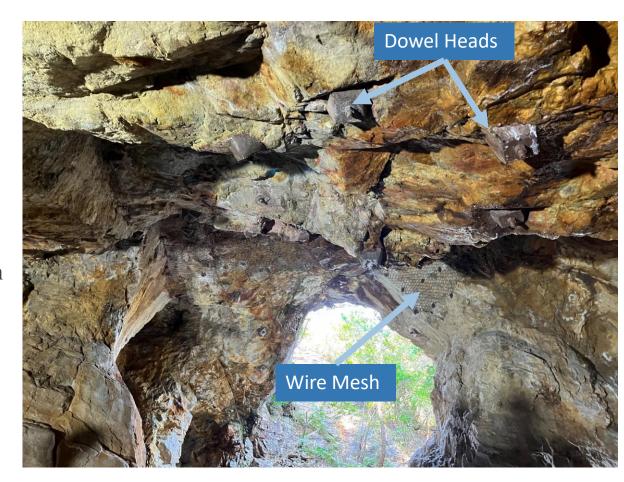
- 3) Maintain Authenticity of Heritage
- **Solution**
- Holistic finishing & landscaping
- I. Brown pigments for **dowel heads & wire mesh**
 - i. to blend in with the rock colour of weathered tuff in association with iron staining

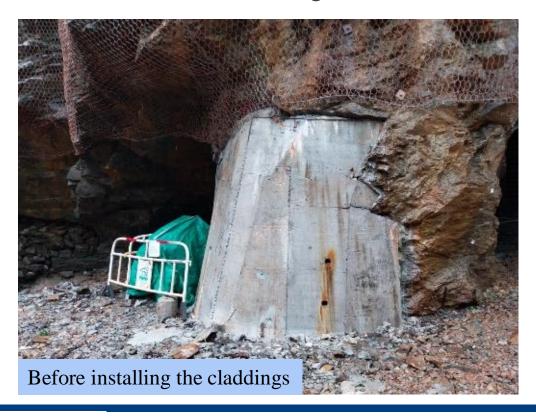
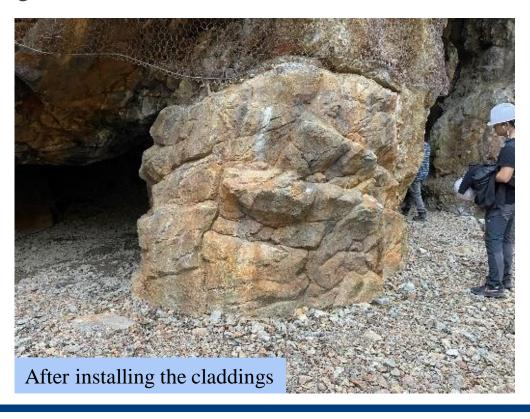
- 3) Maintain Authenticity of Heritage
 - II. Artificial Rock Cladding for Concrete Surfacing Buttress B1

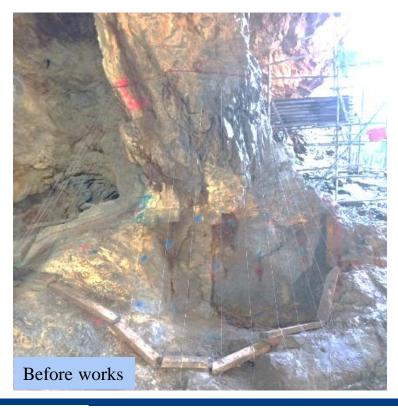
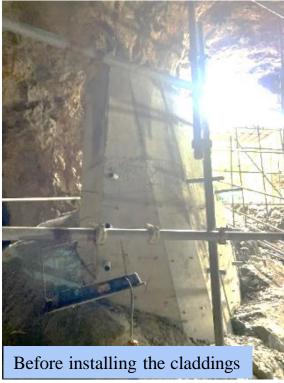
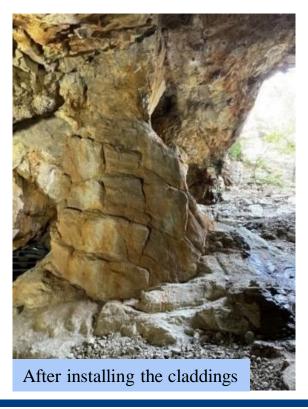
- 3) Maintain Authenticity of Heritage
 - II. Artificial Rock Cladding for Concrete Surfacing Buttress B2

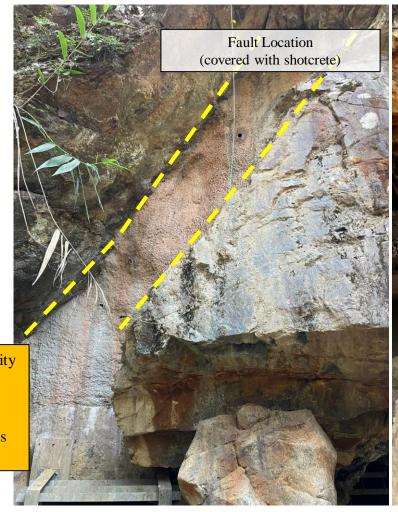
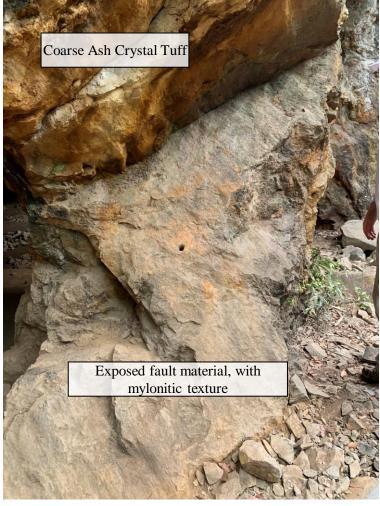
View along Strike

- 3) Maintain Authenticity of Heritage
 - III. Preservation of GeologicalFeatures of Special Interest –Faulting Mylonite Zone

As the fault zone is almost <u>1m wide</u>, it poses threat to stability of the overlying material. Therefore, shotcrete is applied on its surface to prevent further erosion and deterioration.

- Buttress has also been constructed to support the rock mass at the footwall.
