# AGS (HK) TECHNICAL VISIT

*Foundation for Public Rental Housing Development  
at Sha Tin Areas 16 & 58D Phase 1, Fo Tan*

*10<sup>th</sup> October 2015*

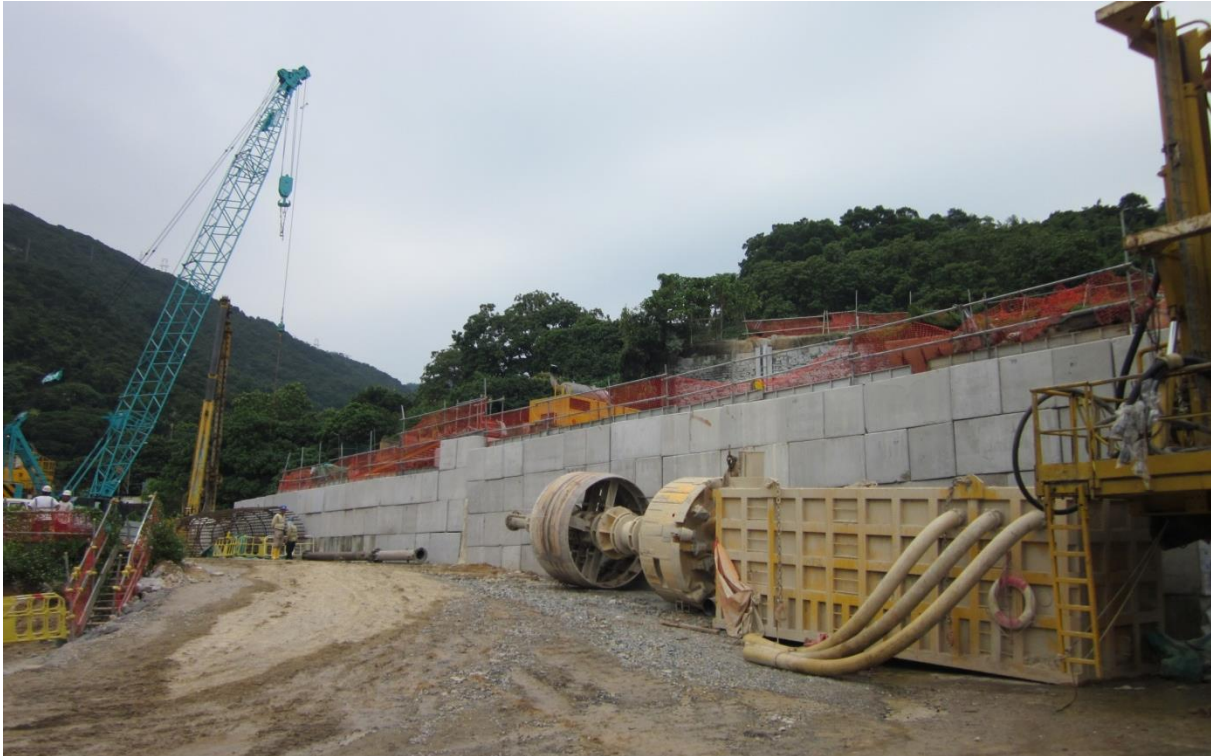
**Figure 3** - Traffic ramp and modular block retaining wall

The difficulties imposed by the natural terrain were overcome by traffic ramps and temporary piling platforms. These were supported by modular block retaining walls comprising 1 m × 2 m segments (**Figure 3**). A shoring system of pipe piles, sheet piles and struts was also employed on site. Google SketchUp was used effectively to examine logistical and spatial constraints associated with the various construction activities.

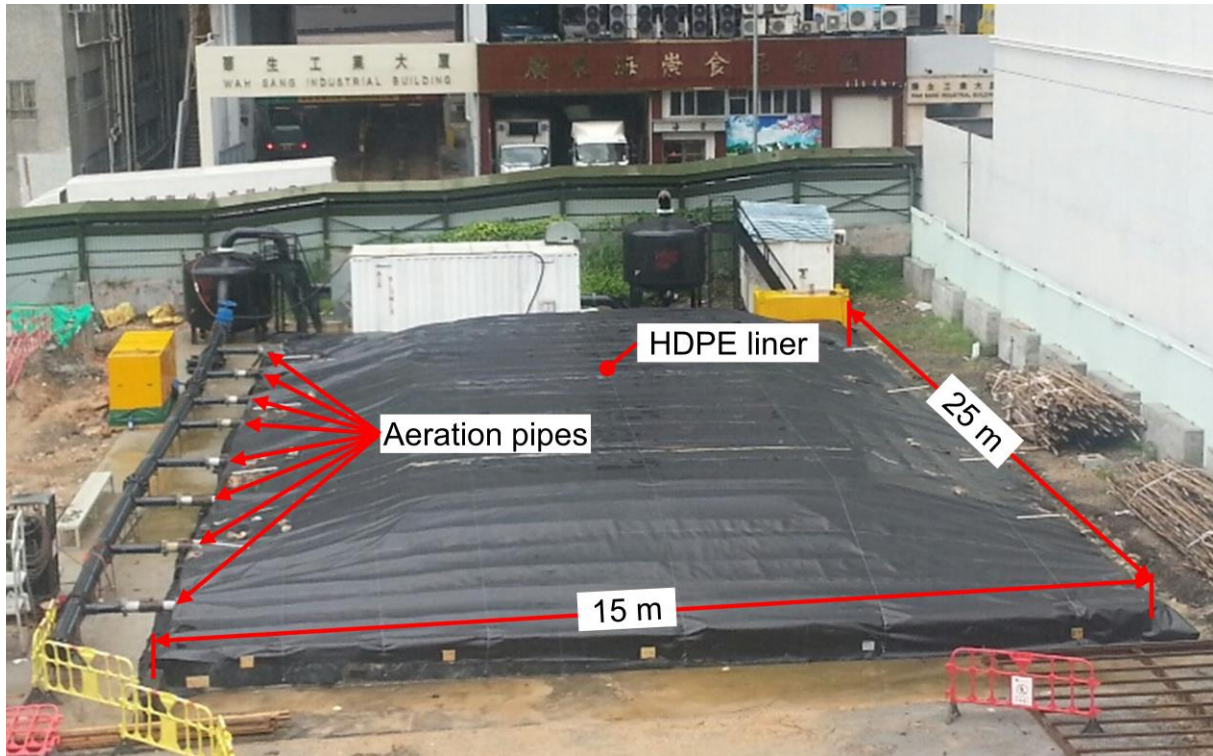
**Figure 4** - Bio-pile unit used to reduce organic contamination in soil

Elevated levels of lead and organic contaminants were encountered on this site. Cement stabilisation was employed to reduce the lead concentration in approximately 140 m<sup>3</sup> of soil and prevent leaching of this heavy metal. However, Prof. Yeung raised an important concern about future leaching if the soil reverts to an acidic state post-treatment. Organic contaminants in the form of DEHP and PCR were present in approximately 375 m<sup>3</sup> of soil. This soil was excavated using bored piles and subsequently treated with bio-remediation. This technique utilises a 15 m wide × 25 m long bio-pile unit, which contains a 1.5 m thick layer of contaminated soil underlain by 100 mm of sand. Aeration pipes run through the contaminated soil layer and the entire unit is wrapped in a HDPE liner (**Figure 4**).

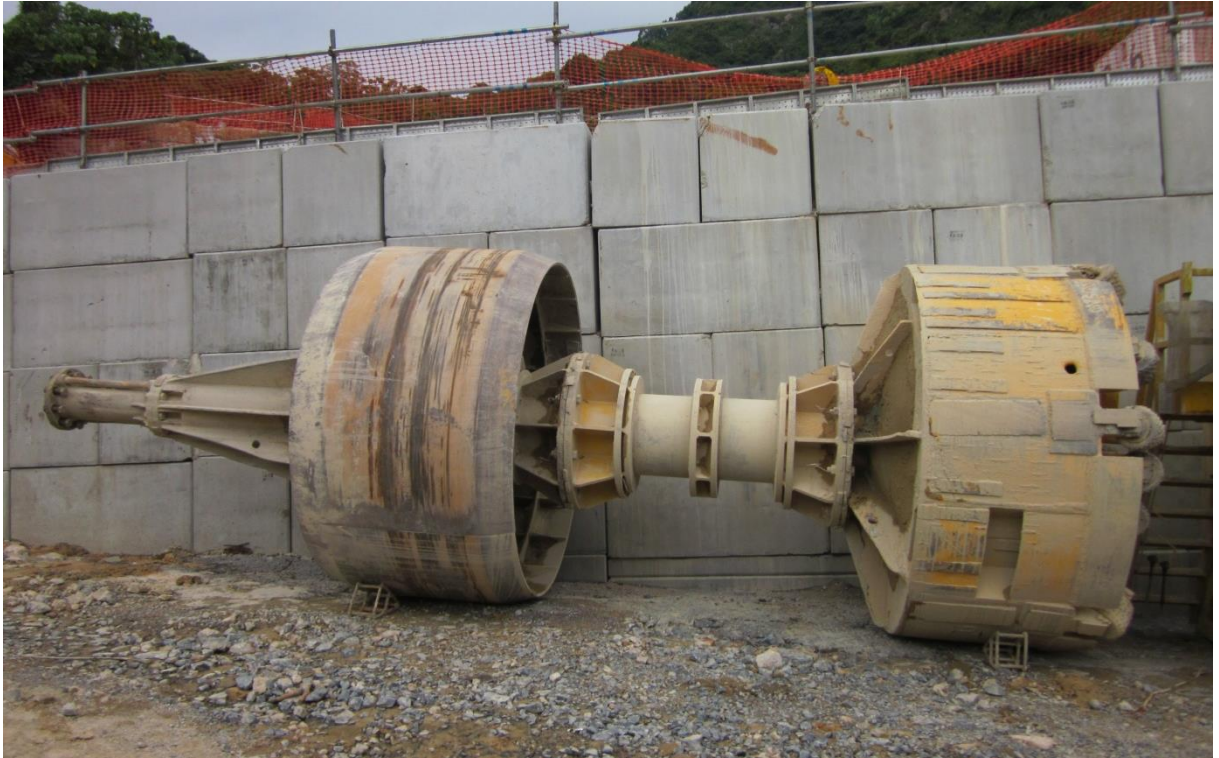
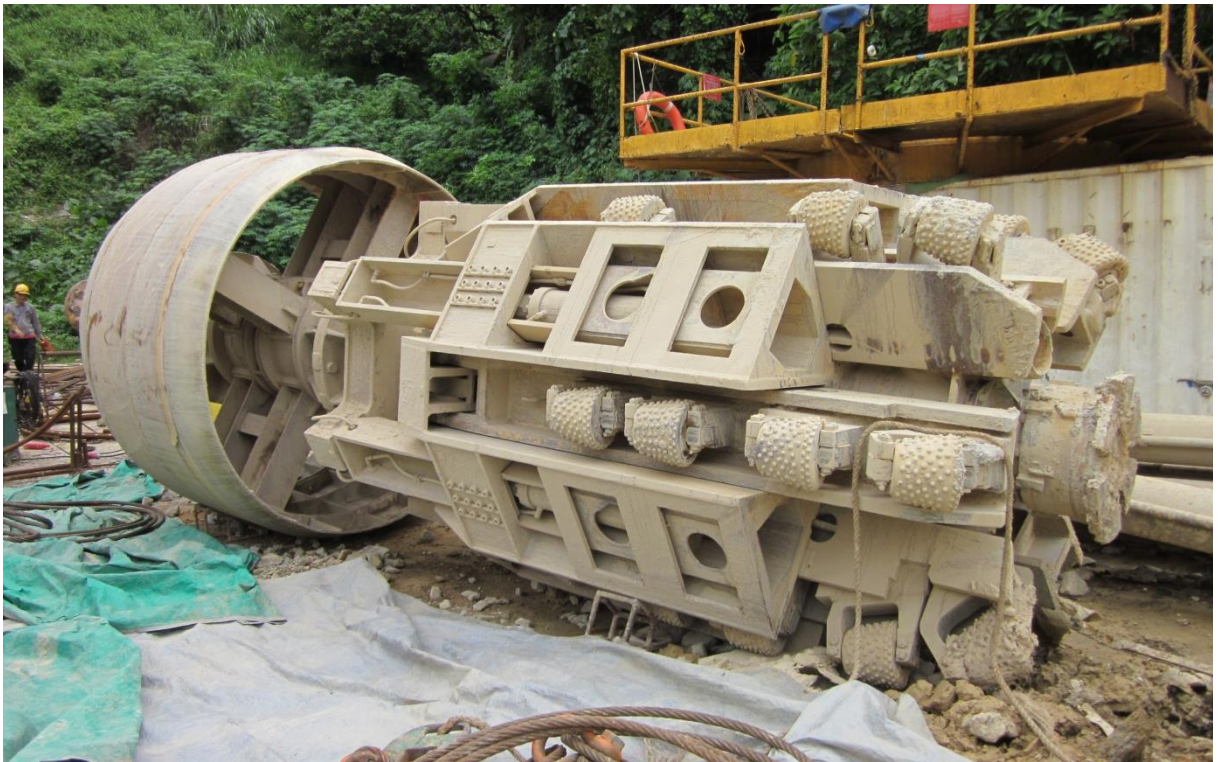
(i)

(ii)

**Figure 5** - Mechanical drill-heads for (i) standard boring and (ii) bell-out at base

The residential blocks were supported by 99 no. large diameter bored piles and raft footings, while the commercial centre was supported by 65 no. socketed steel H-piles. The bored piles ranged from 2.5–2.7 m in diameter and 15–22 m in length. It was necessary to form an even larger diameter (3–3.2 m) hole to facilitate a permanent steel lining. This lining prevents ingress of soil/water during curing and protects piles in the long term. The piles were formed using the RCD technique and socketed into bedrock. A special attachment was used to form a bell-out at the base (**Figure 5**), before inserting the steel cage (**Figure 6**).

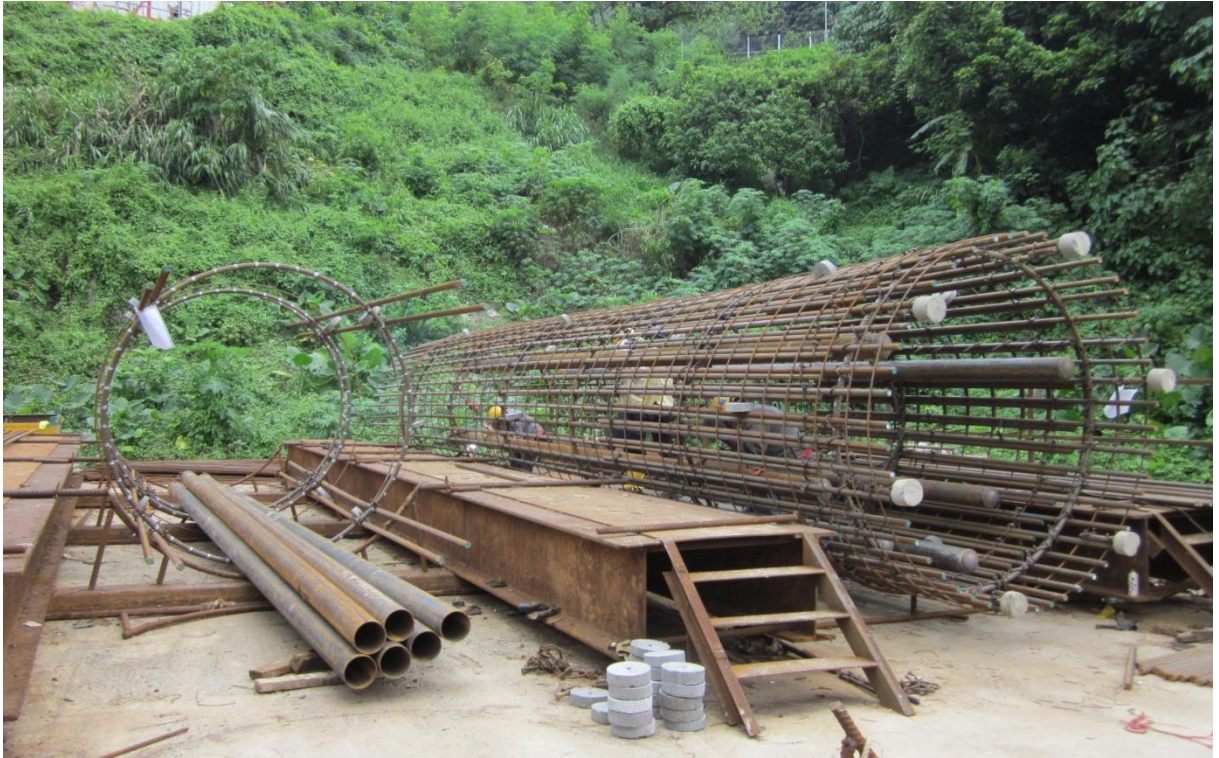
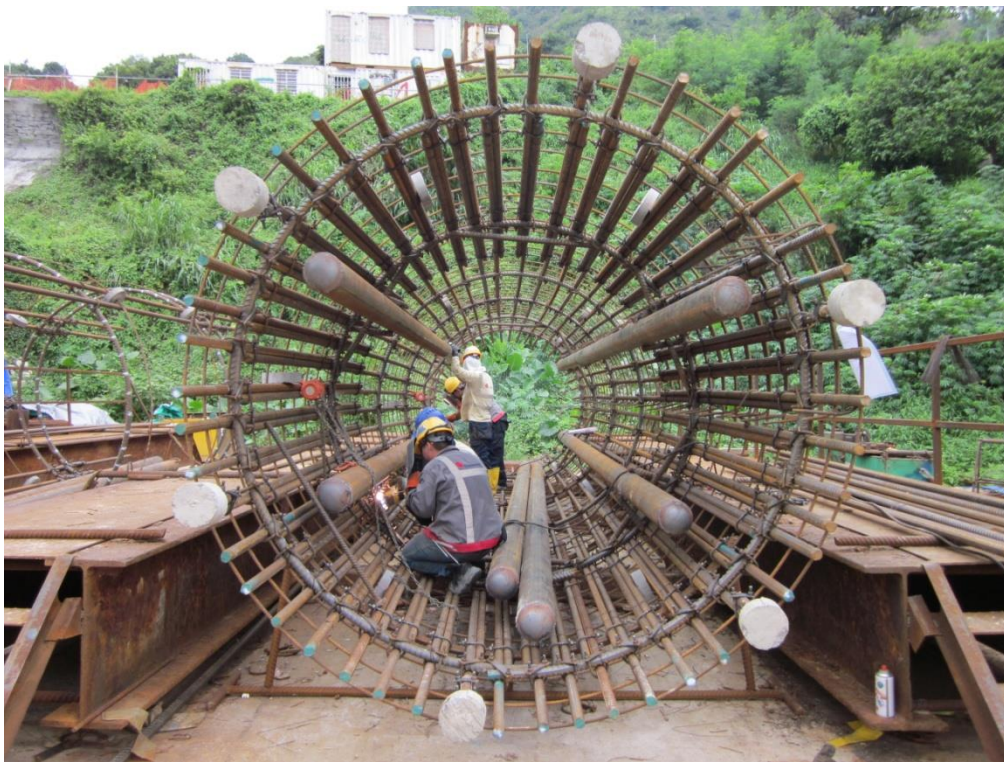
(i)

(ii)

**Figure 6** - Steel reinforcement cage: (i) side and (ii) end view
